## Field Survey in Iringa Municipal for Identification Sensitization and Selection of Potential CW Adopters

## Dissemination of the Sustainable Wastewater Technology of Constructed Wetlands in Tanzania

December 2012

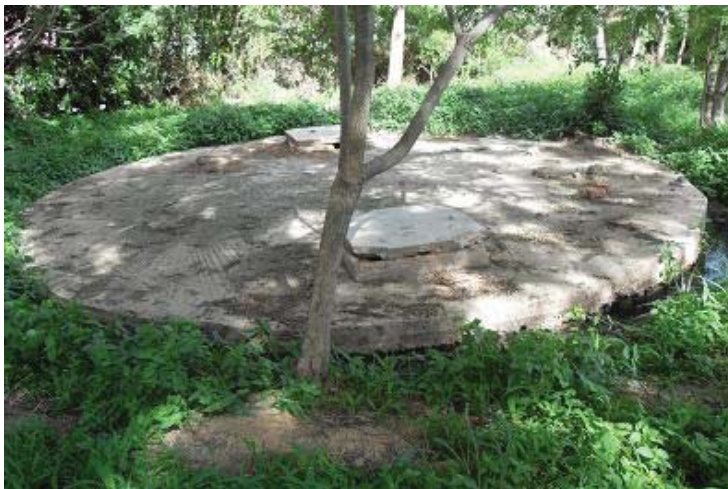
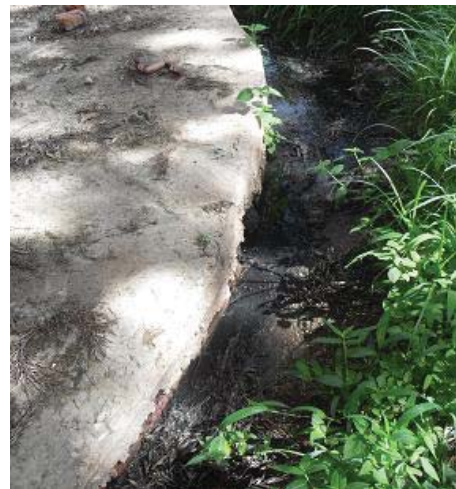
**Figure 1.1 (a) and (b):** Situation of soak away pit at IGSS

There is exist of two soak away pits at IGSS, the old and the new soak away pit. Before constructed the new soak away pit the problem of overflowing was very critical. The emptying was relatively high resulting to high operation costs. Owing to this reason, the school management decided to construct the new soak away pit with the expectation of cutting off the overflowing problems. In line with the soak away pit the school decided to separate the grey water from the bathroom and those from the toilets. The old septic tanks were receiving the effluents from the toilets and the new soak away pit was receiving the effluents from bathroom.

Despite of the effort made to solve the problem, the condition of the soak away pit still remained unsolved. The situation became worse since the student uses the toilets for bathing which overloaded the old septic tanks. Therefore the old soak away pit was failed to retain wastewater, due to the leakage from the wall of the soak way pit (Figure 3.1 (a) and (b)). The wastewater scattering all over the soak away pit implies the saturated of the soil and high water table within the area.

(a)The existing soak away pit

(a)Failure of a soak way pit

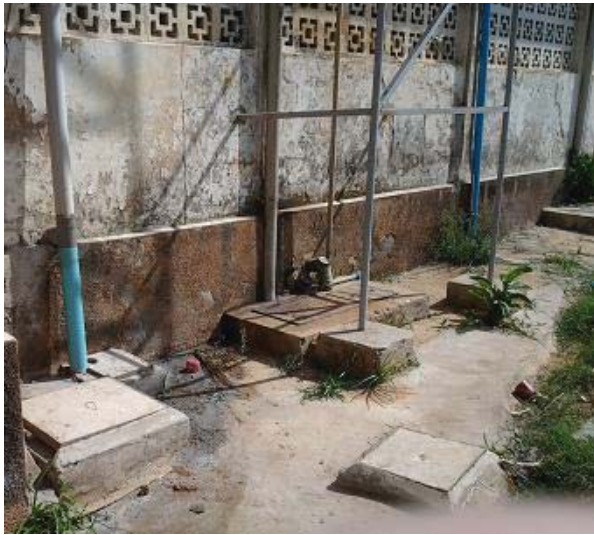
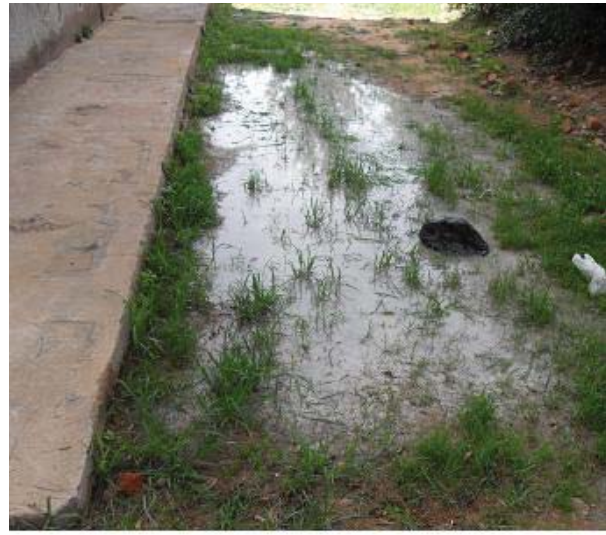
**Figure 3.2 (a) and (b):** Situation of chambers during inspection at IGSS

The school has considerable number of chambers, of which most of them are still in a good condition and 4-5 chambers have been added to one of the dormitory.

(a) Inspection chamber receiving water from washrooms of the dormitory at IGSS (b) Overflowing of chamber after bathing at IGSS

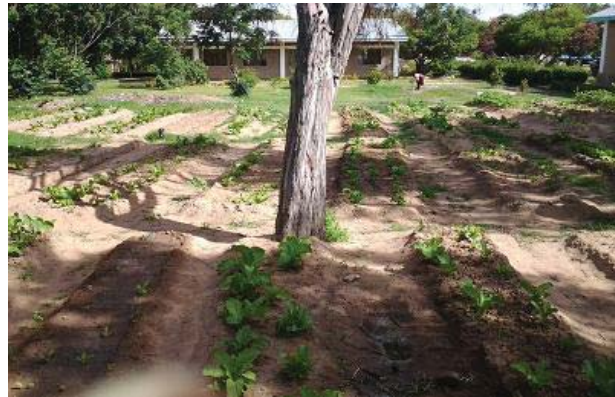
The school has a vegetable garden which is located very close to the soak away pit. Despite of the huge amount of wastewater generated, the school still consumes the IRUWASA water supply for irrigation (Figure 3.4). This implies that the school incurs double payments, first they incur a cost of emptying their soak away pit frequently and second they incur extra cost of paying water supply for irrigation. Therefore, there is a need of treating wastewater, and then reuse for

**Figure 3.4:** Vegetables irrigated by IRUWASA water supply at IGSS

irrigating their vegetables garden. The innovative project of constructed wetland is expected to be a heartbeat for reducing the expenses but also will enhance the quantity and quality vegetables through the irrigation practices.

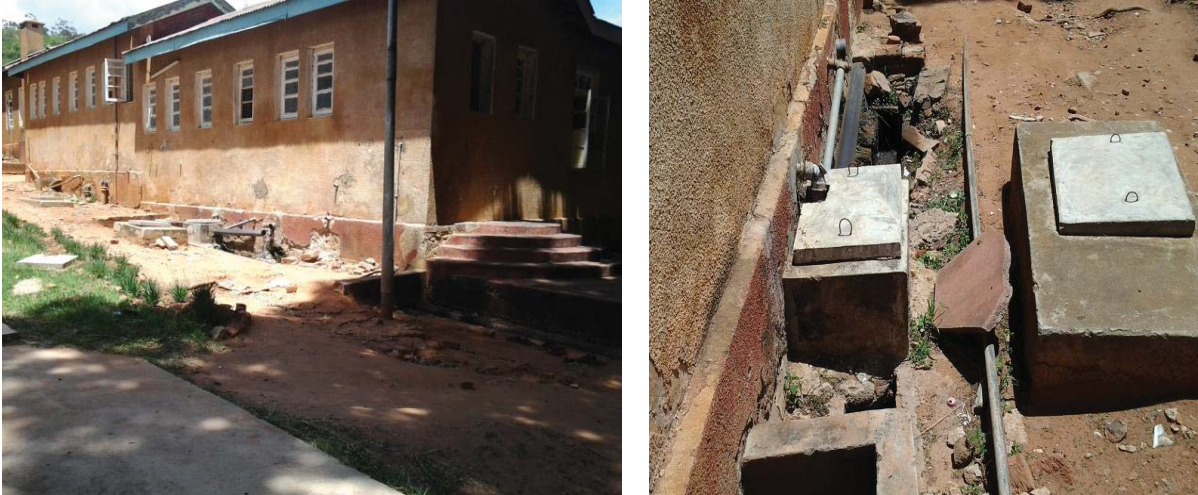
The rapidly increase of students at Lugalo secondary school has posed a remarkable problem of wastewater management. Despite of the large wastewater generated due to the increase of students, the infrastructure of the wastewater management has remained the same and no repair has been done since 1945. Therefore the infrastructure is generally too old to be used for

wastewater collection (Figure 3.5). The overflowing of septic tanks is common at LSC. Each of these infrastructures is explained in details in the following sections.

**Figure 3.5:** The old infrastructure of wastewater collection in toilets of LSS

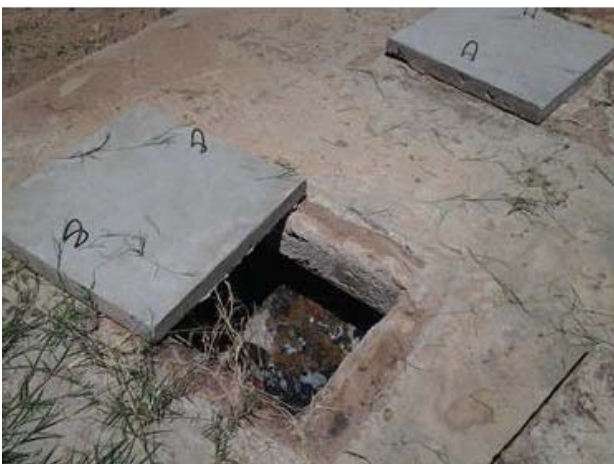
**Figure 3.6 (a) and (b):** Septic Tank at LSS

Lugalo Secondary Schools use septic tanks and soak away pits for wastewater treatments and disposal. There are three soak away pit systems located at A level dormitories and O level dormitories. These systems are receiving only wastewater from toilets. Other water such as washing water and bathroom water is drained directly to the existing stream.

(a)Septic Tanks at A'level dormitory

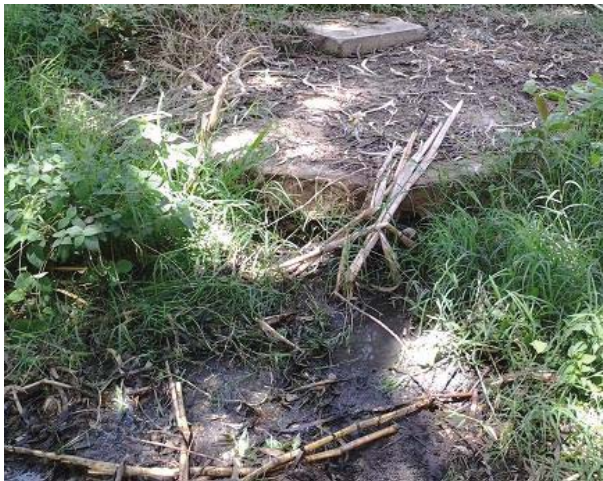
**Figure 3.7 (a) and (b):** Overflowing soak away pit and new soak away pit respectively at LSS

The School has three soak away pits which work separately, receiving the effluents from the septic tanks at O’level and A’ level dormitories. According to the interview held by the head teacher Mr. Kabungo, the overflowing of the soak away pit is common which resulting to high frequency of emptying the soak away pit. The empty of the soak away pit generally occurred 1 to 5 times per month. These imply the high cost of maintaining the septic and soak away pit systems at Lugalo secondary School.

(a) Overflowing Soak away pit

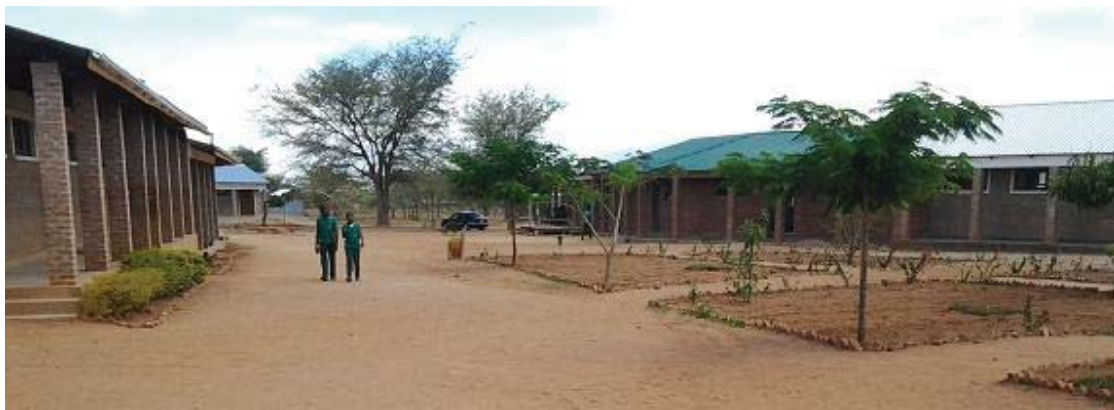
The wastewater generated by washing activities like washing clothes and bathing is used for irrigating the flower within the school compasses (Figure 3.9)

**Figure 3.9:** The compasses of ESS

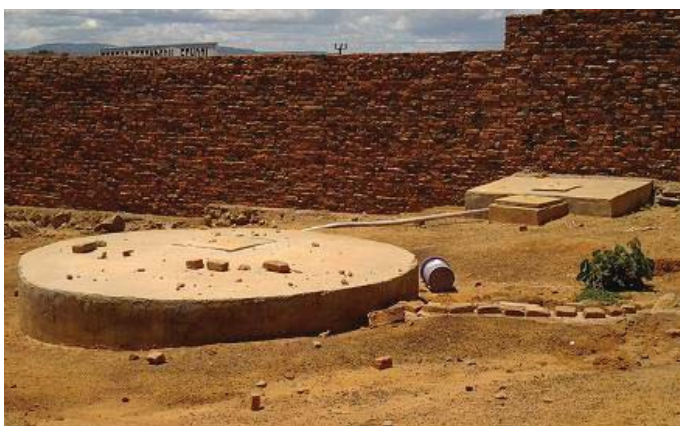
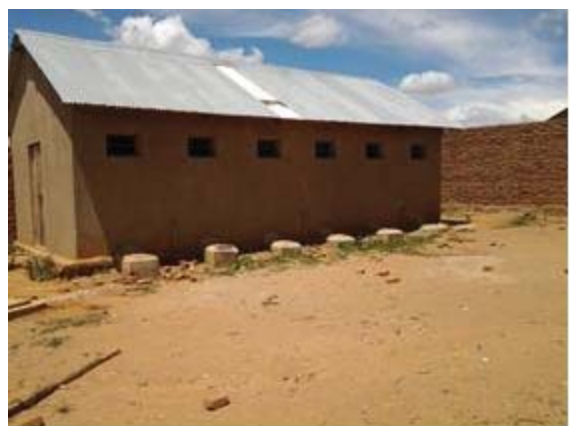
**Figure 3.10 (a) and (b):** Septic tanks and soak away pit; and bathroom and toilet at EfSS

The wastewater treatment/sanitation facility which is used at Efatha Secondary School (ESS) is the combination of septic tank and soak away pit (Figure 3.10). Recently the wastewater management is not a problem at ESS, but the toilet has been flushed manually which may cause the blockage of the pipeline due to the low pressure of water to convey the sewage into the septic tanks. The school compasses is very dry no any agricultural activities has been carried out. The school management however they are planning a project of growing shadow trees within the school compasses. This implies the reuse of the wastewater generated for irrigation.

(a) Septic Tanks and Soak away Pit

(b) Bathroom and Toilets

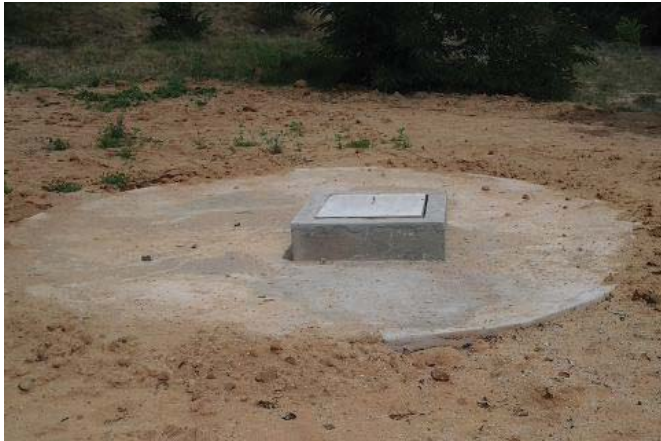
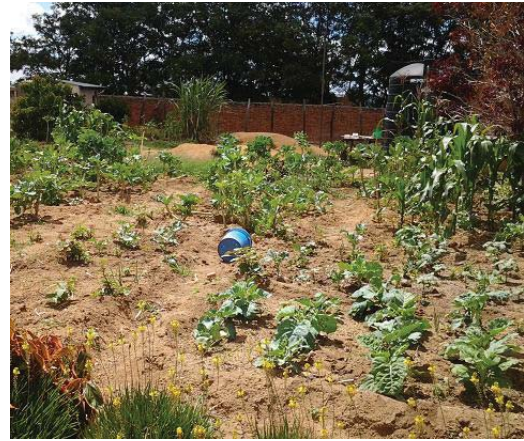
**Figure 3.11 (a) and (b):** Wastewater collection points and Agriculture activities respectively at CGSS

The sanitation facilities that were currently used at CGSS were flush toilets and wastewater management system which was used in the combination of septic tanks and soaks away pits. There was no reported case of overflowing of the system rather than history of relative high frequency of pits emptying due to significant huge amount of wastewater generated. The school management had recently decided and built a new and big soak away pit in order to minimize the rate of emptying soak away pits. Therefore there was no sanitation/wastewater management problem at CGSS.

(a) Collection point of wastewater in CGSS

(b) Agriculture activities at CGSS using IRUWASA water supply
